Reference: ACC2 Jack

Kenwood TS-850 w/DSP-100 Receiver Modifications Before/After Mods

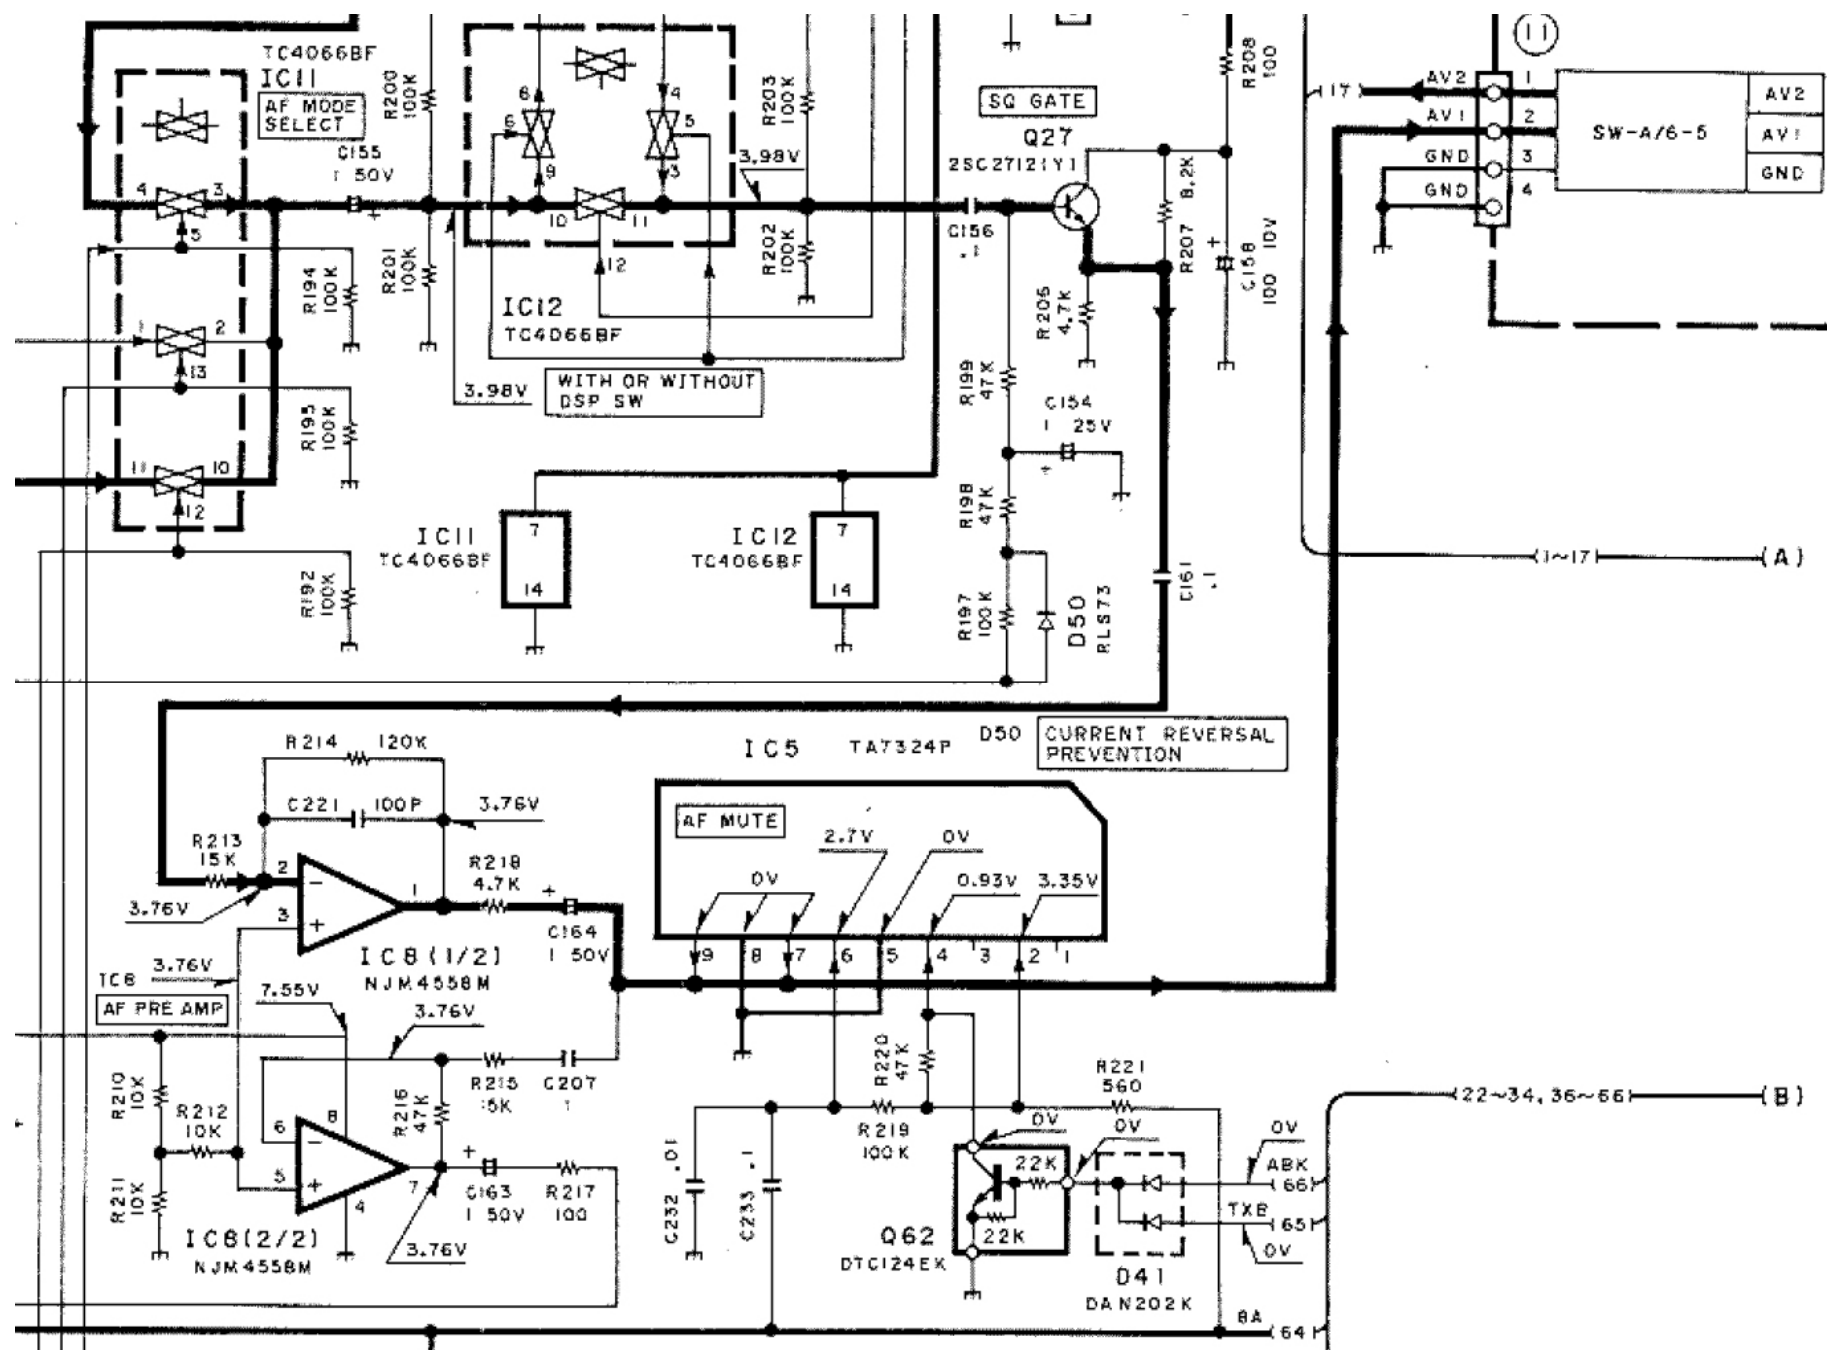
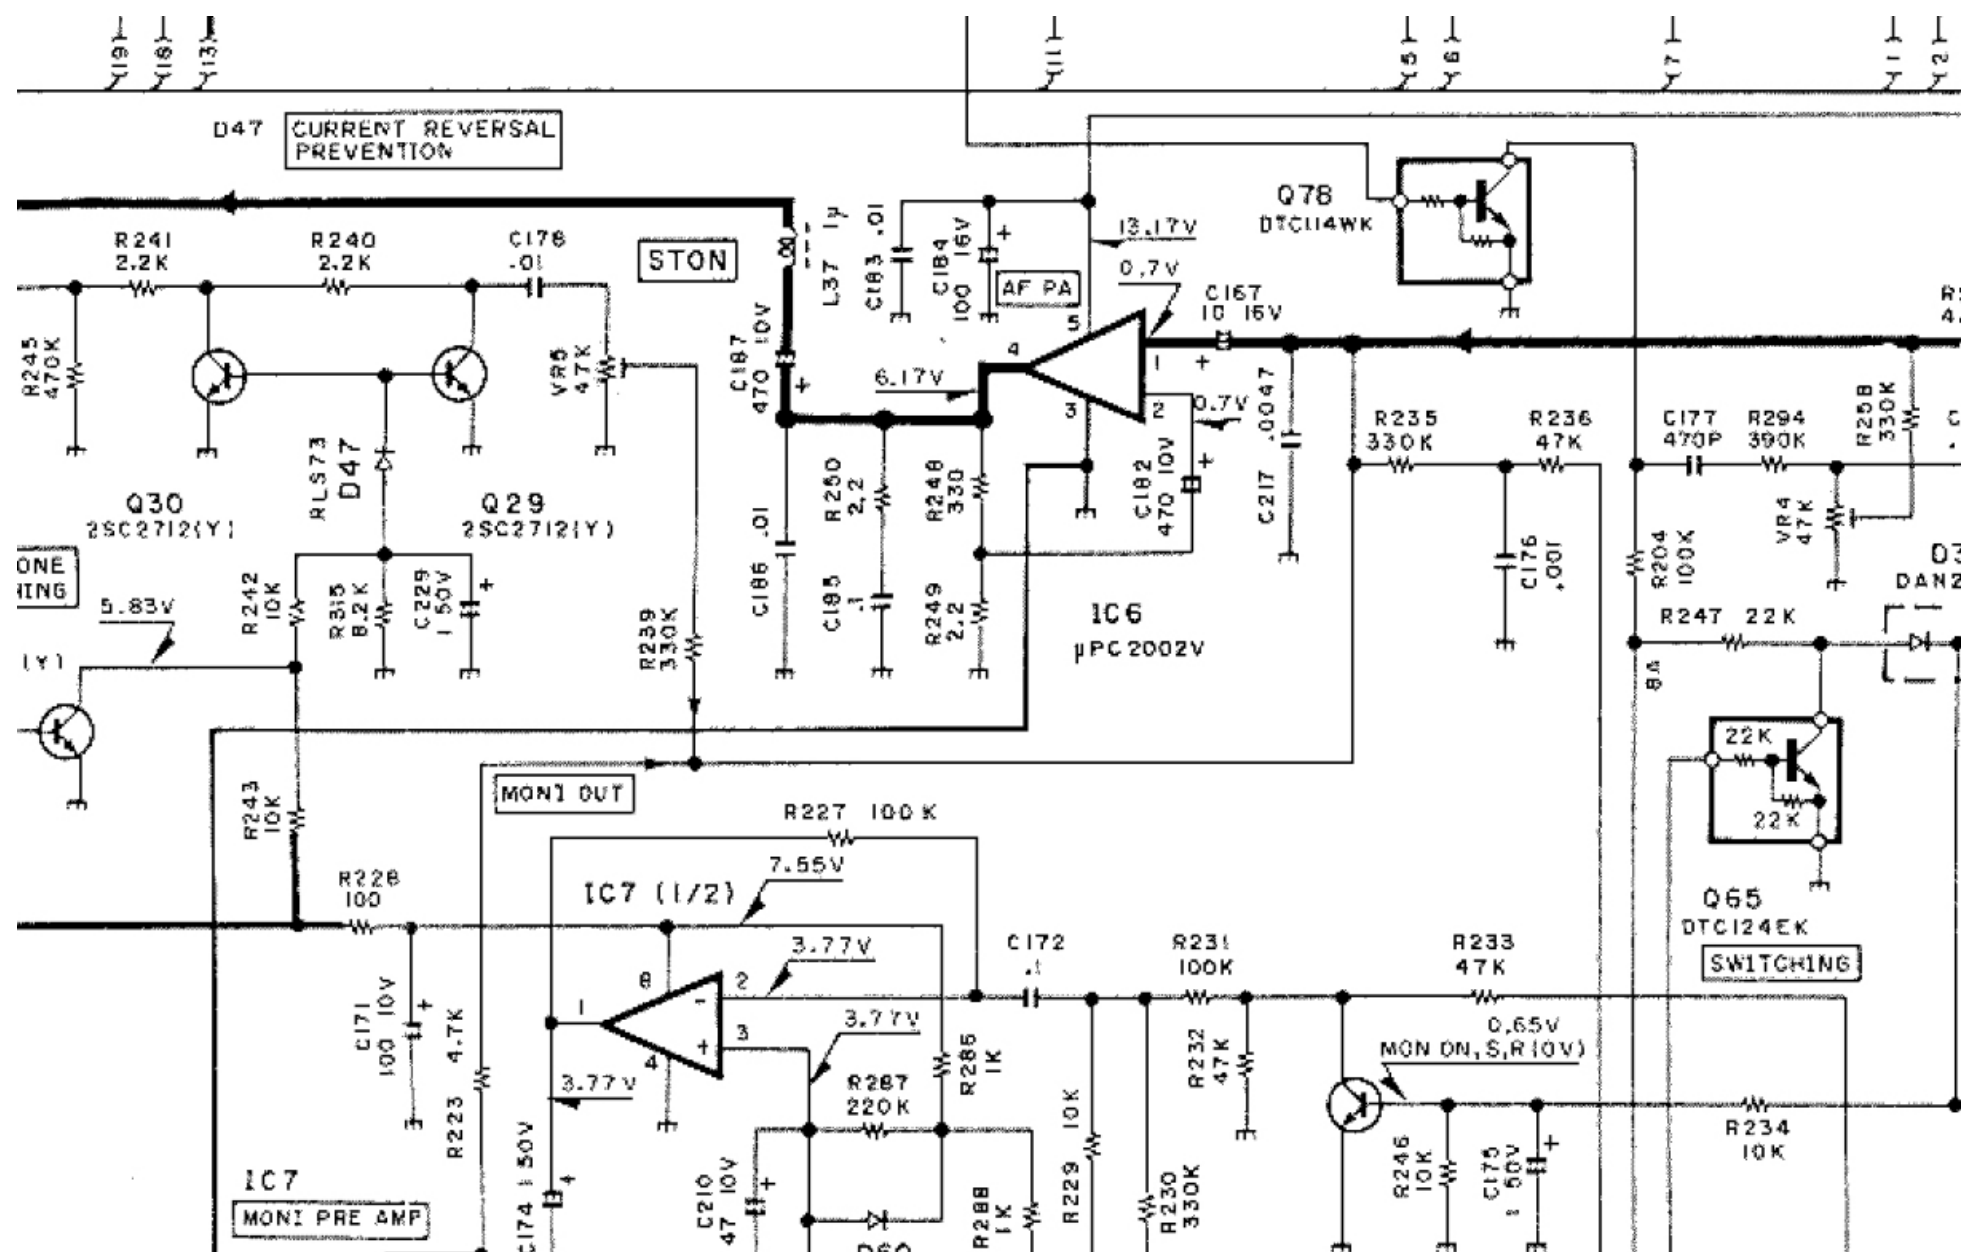
* Note1: C155 is mis-labeled as C153

** Note2: C163 is mis-labeled as C169

Note 3: C151 and C172 are on the FOIL Side of the Board!

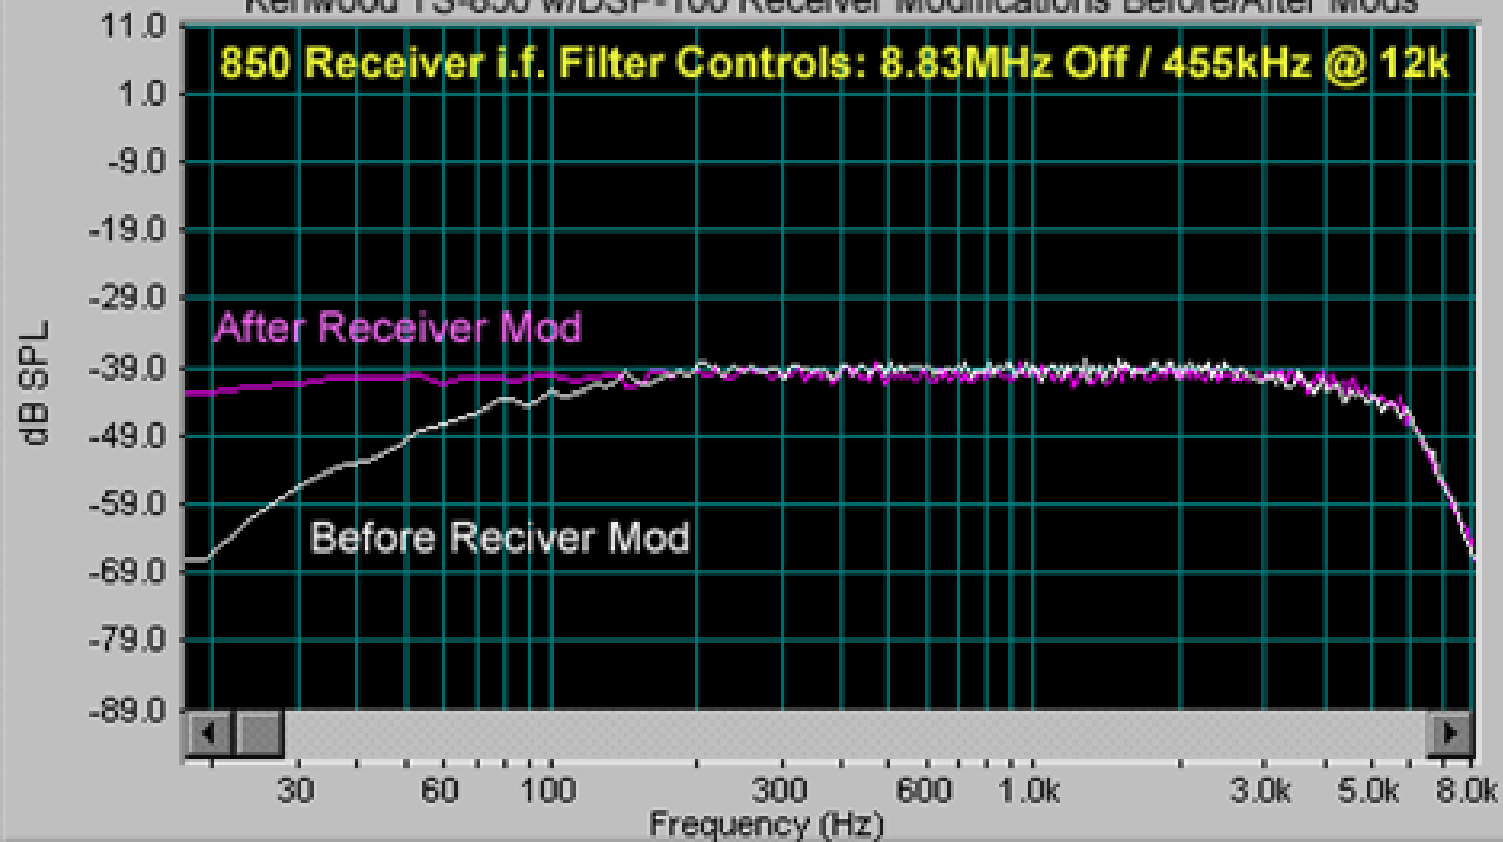
850 Receiver i.f. Filter Controls: 8.83MHz Off / 455kHz @ 12k
